Implant-prosthetic rehabilitation

Dr. Maxi Cacciacane García, Spain
Specialist in Prosthetics

Case Description

A 58-year-old male patient with 6 upper implants to be rehabilitated.

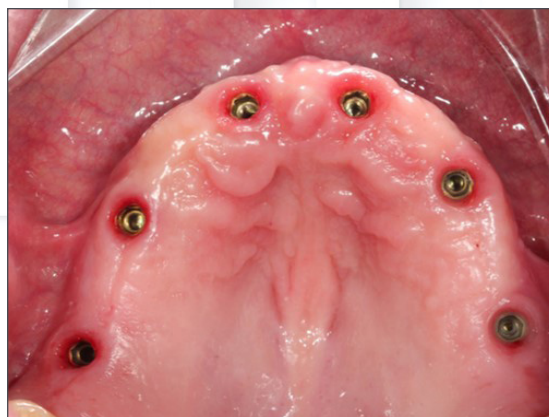
Image 5

Pre-operative image of the 6 upper implants.

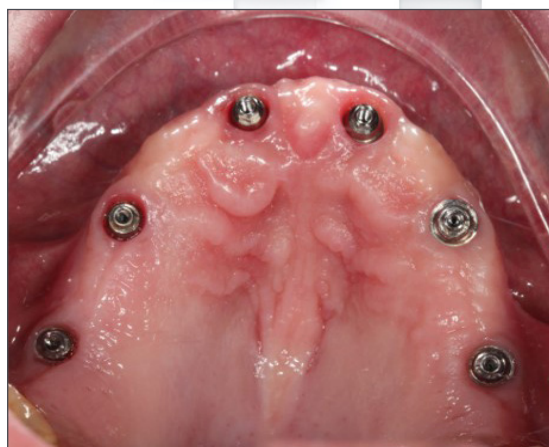
Image 6

Multi Units were placed in order to achieve the greatest passivity for the future rehabilitation.

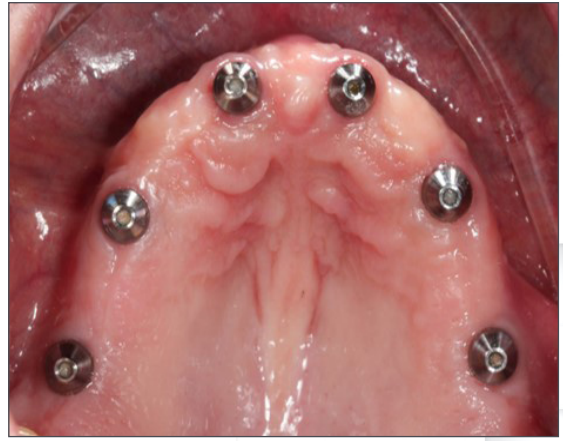
Image 7

Healing abutments for multi-unit.

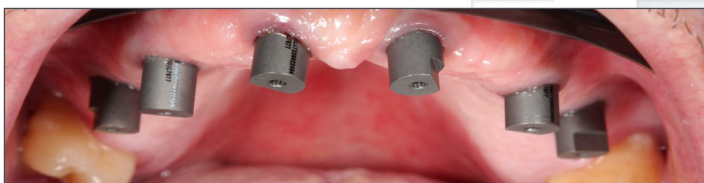
Images 11 & 12

Image of the scan with OVO 3DISC Scanner.

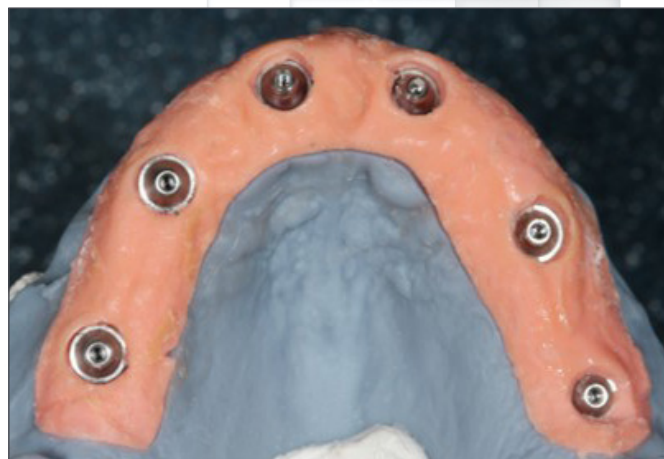
Image 13

Final printed model.

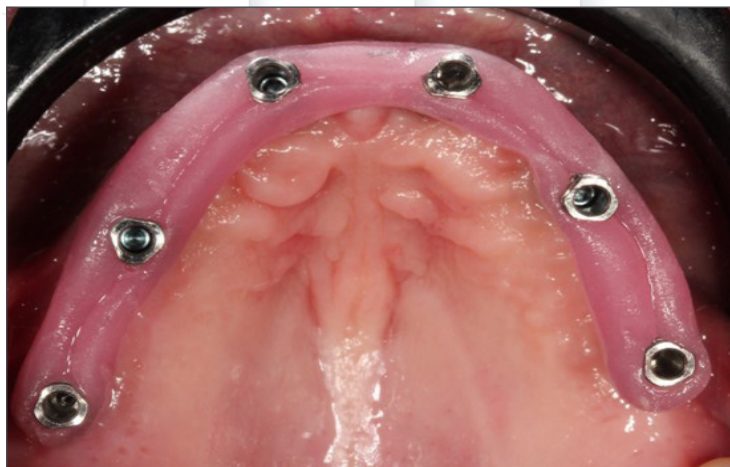
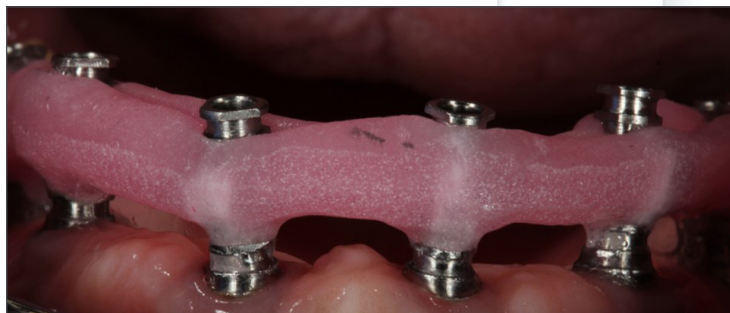
Images 14 & 15

Transfer and passivity check.

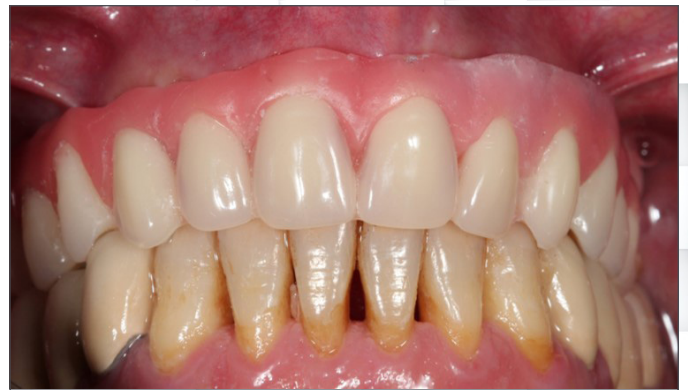
Image 17

Tooth test: Here we decide whether to perform an FP1 or FP3 prosthesis.

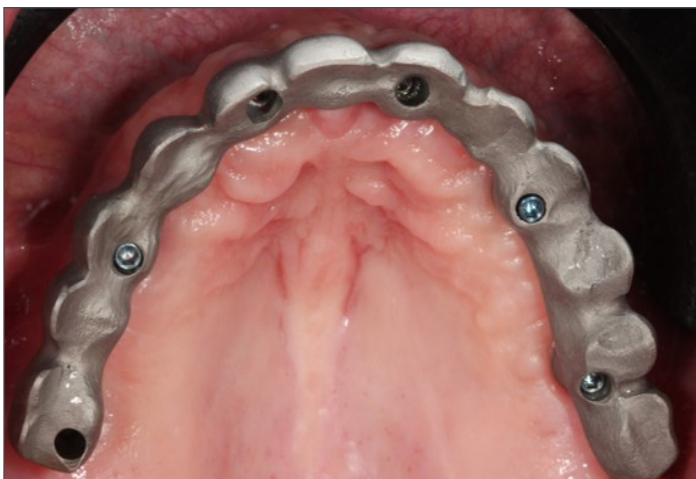
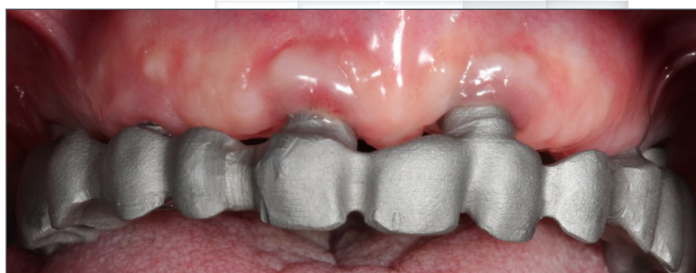
Images 22 & 23

Metal structure test

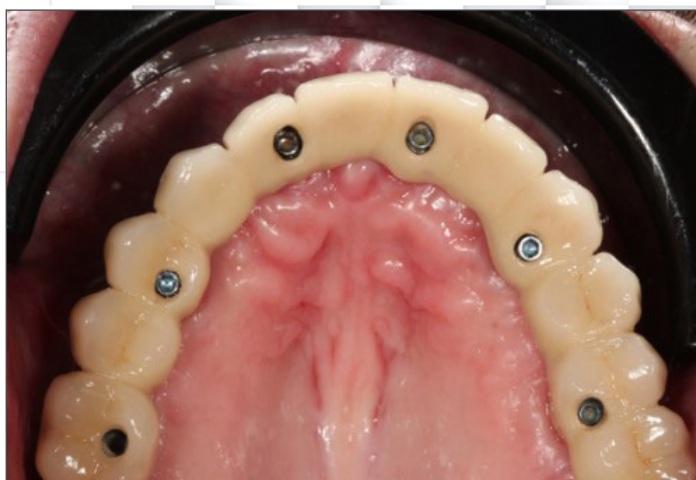
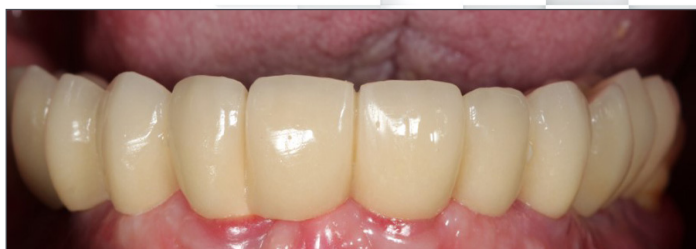
Images 24 & 25

Ceramic-metal rehabilitation
